CASE STUDY

**“Best value” solution  
for make-over  
higher education  
facilities**

**APPROVED CONTRACTOR:**  
Roofing Contractor Cambridge Ltd

**CLIENT:**  
Northmores

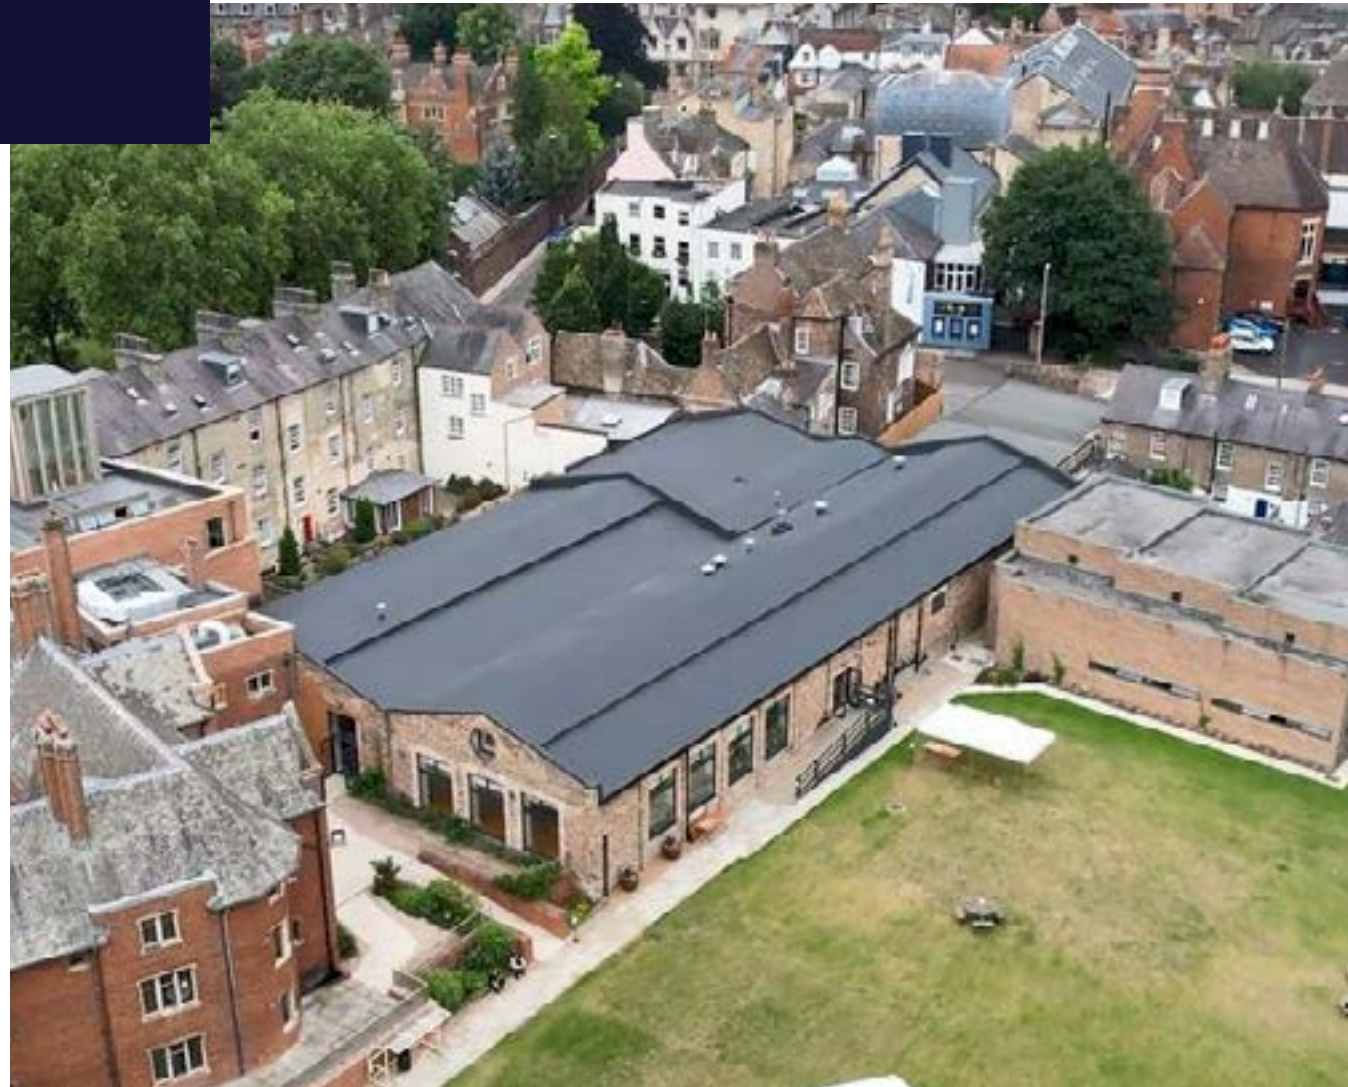
Northmores turned to Langley to devise a cost-effective solution for the roofing element of the project, instructed by principal contractor Regent Construction. An in-depth roof condition survey found that the existing felt waterproofing had blistered with age, and the bank of Georgian wired glass northlights that ran the length of the building were fragile and in need of urgent removal for safety. There was also a number of flues, plant kerbs, internal gutters and a quantity of redundant plants that needed to be addressed.

Langley advised over-laying the existing waterproofing with its TA-20 Flat Roofing System (cold roof application), the existing northlights removed and the penetrations boarded over. Overlaying would help mitigate the cost compared to a roof replacement and also waste to landfill.

Starting with the removal of the roof-mounted plant, and disposal where appropriate, RCC raised all kerbs and outlets to ensure they achieved the recommended 150mm clearance above the new roof covering. Internal gutters were made good to ensure sufficient drainage was achieved. Crash decks were fitted for Health & Safety compliance before work began removing the glass rooflights, and the penetrations boarded over with new joists were fitted where required to achieve the necessary structural support.
